Rimkus Consulting Group, Inc.
Eight Greenway Plaza, Suite 500
Houston, TX 77046
(800) 580-3228 Telephone
(713) 623-4357 Facsimile

Re: RCG File No: 11009971
LLV Number: 0209452
VMF Location: 1530 Greensmark Drive in Houston, Texas
Subject: Final Report

Rimkus Consulting Group, Inc. was retained to examine LLV 0209452, VIN 1GBCS10E4M2908832. The fire occurred on June 13, 2016 at around 12:30 P.M. the operator of the vehicle at the time of the fire, was unavailable for interview but reportedly stated the vehicle's engine died while delivering mail on his route and backfired during subsequent attempts to restart it. Soon thereafter, smoke was observed from beneath the hood as well as flames.

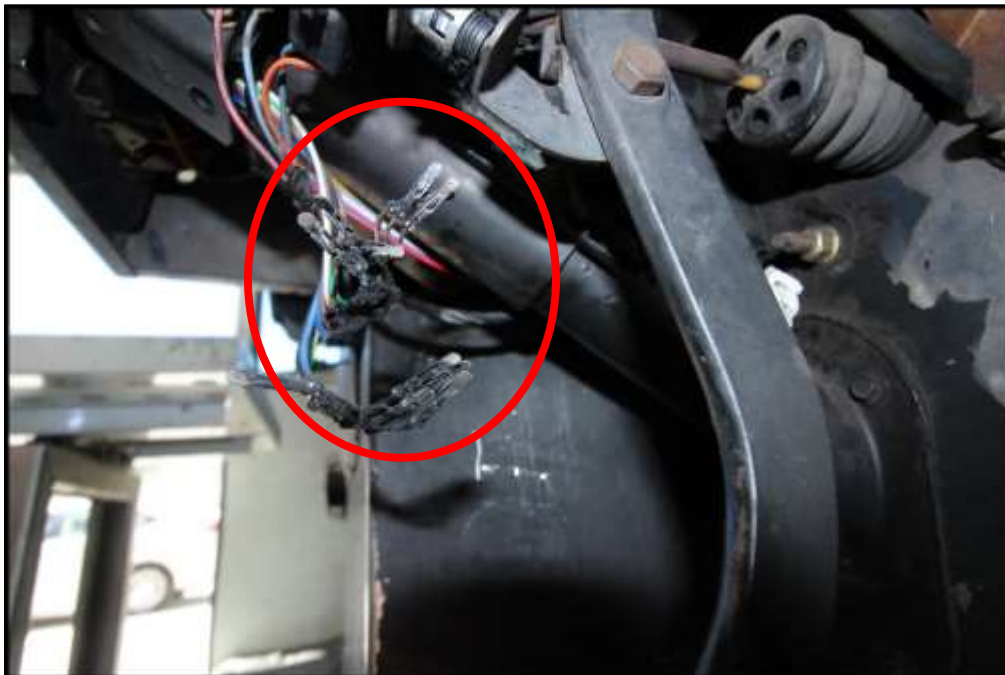
Photograph 2
Fire damaged wiring harness connector from the turn signal switch.

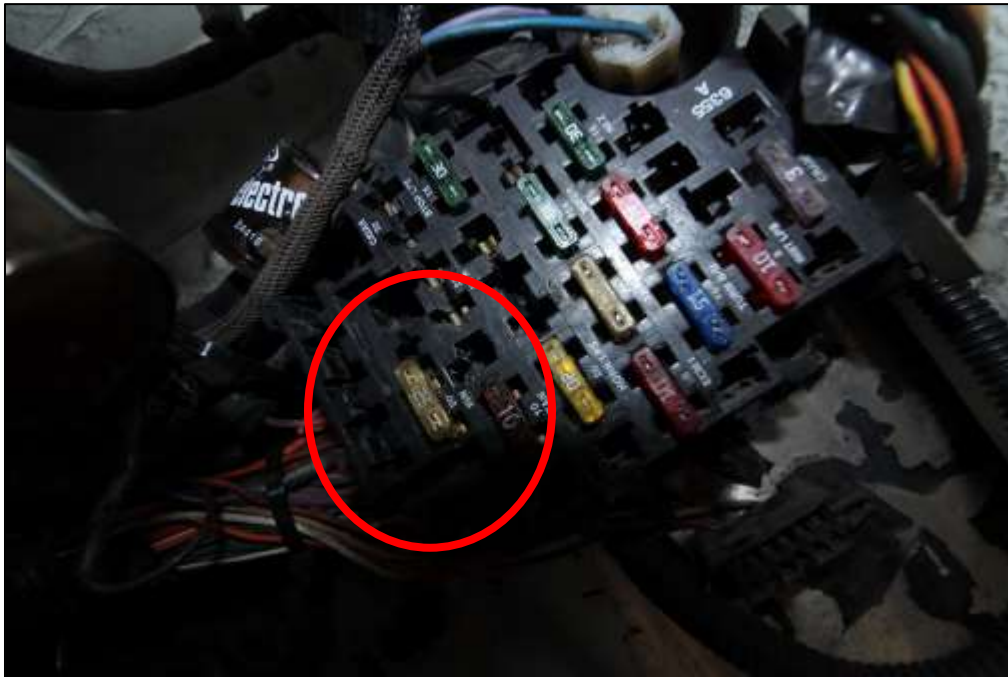
Photograph 3

Fuse box with 25 Amp fuse in a 20 Amp slot for the ignition.

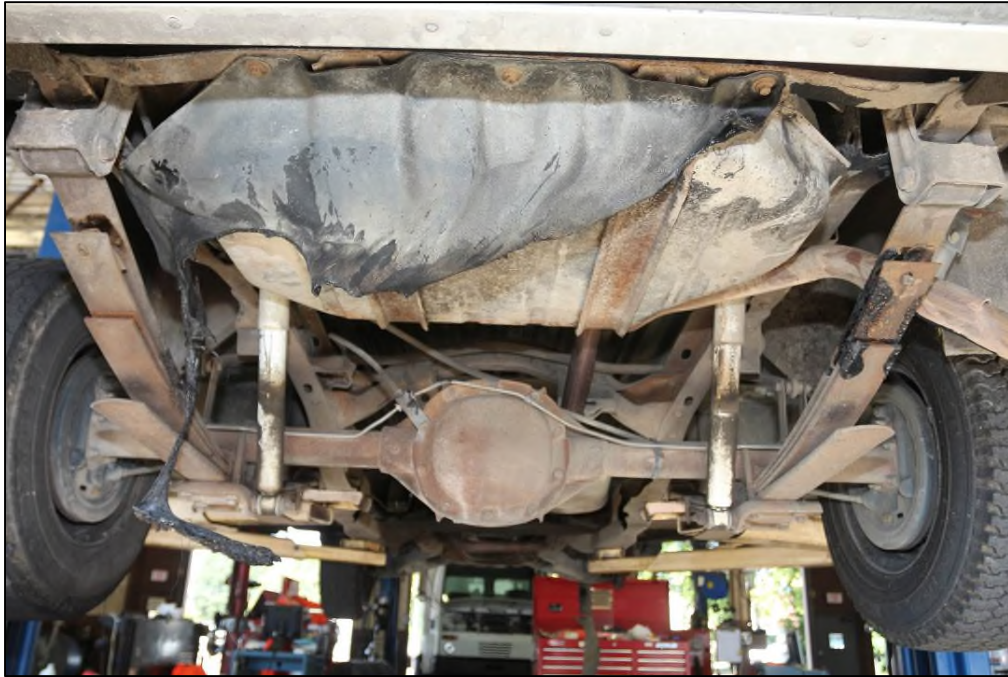
Photograph 7

An overall view of the fuel tank and fire damaged fuel tank shield.

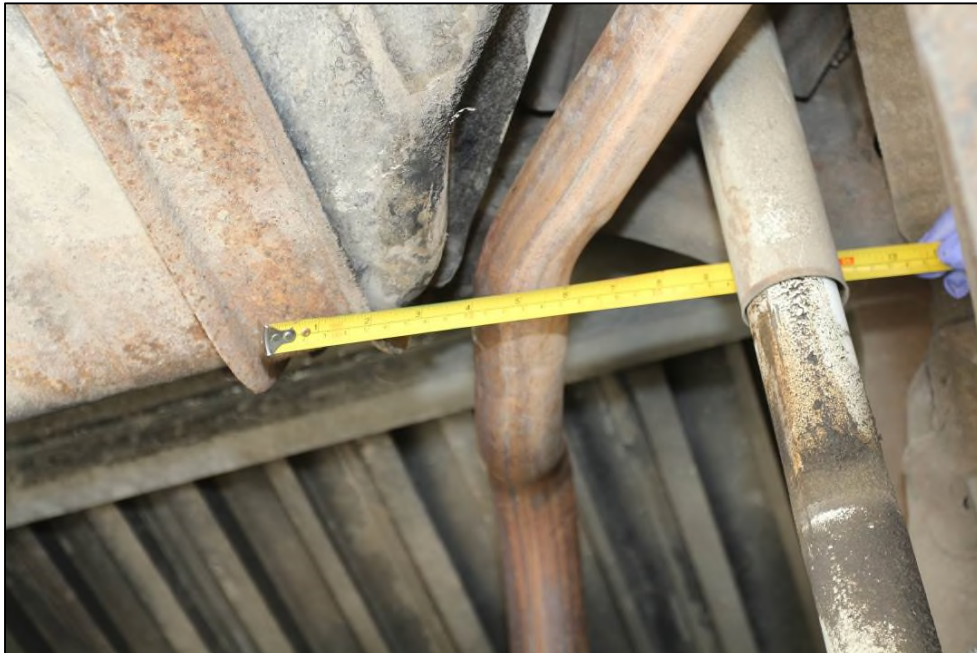
Photograph 8

A view of the tailpipe that was found approximately one-half inch from the fuel tank.

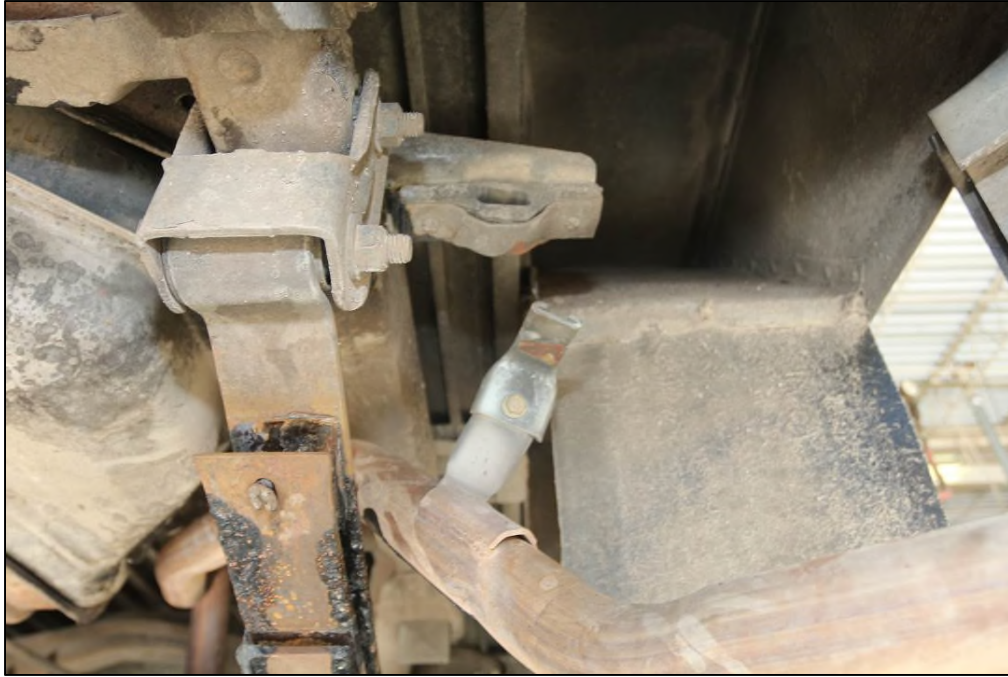
Photograph 9

A view showing the unattached tailpipe and factory mounted hanger.

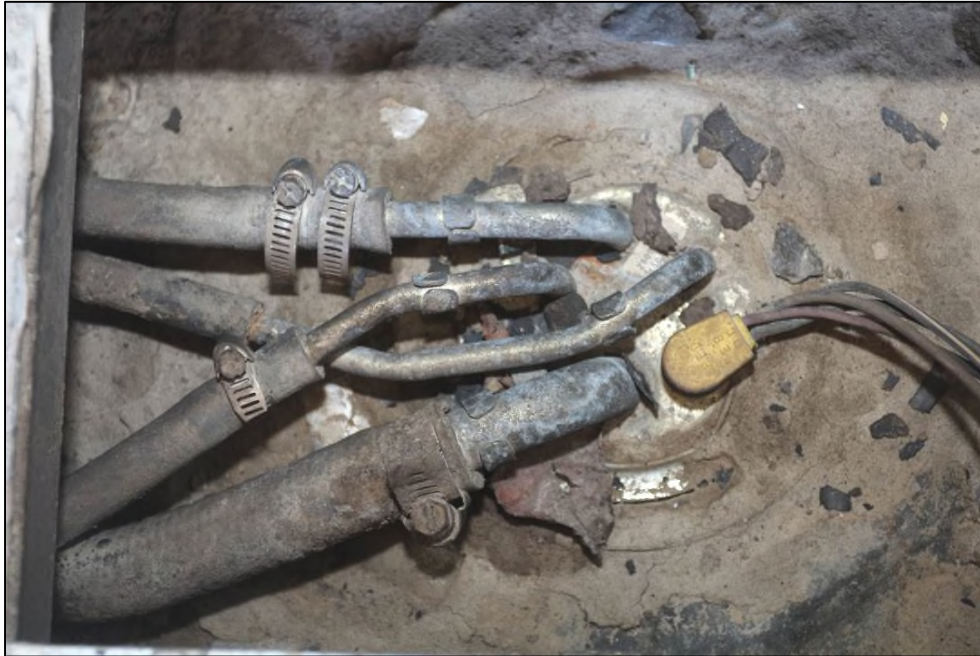
Photograph 11

A view of the topside of the fuel tank where no leaks were observed as well as no fire or heat damage.

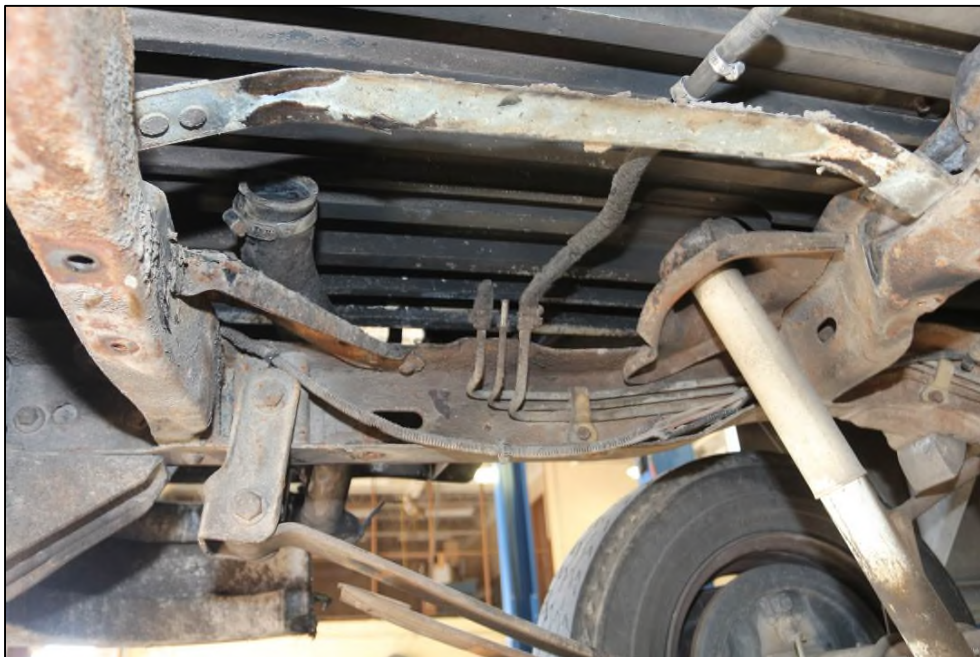
Photograph 12

A view showing the fuel filler neck area where exterior fire attack damage occurred.

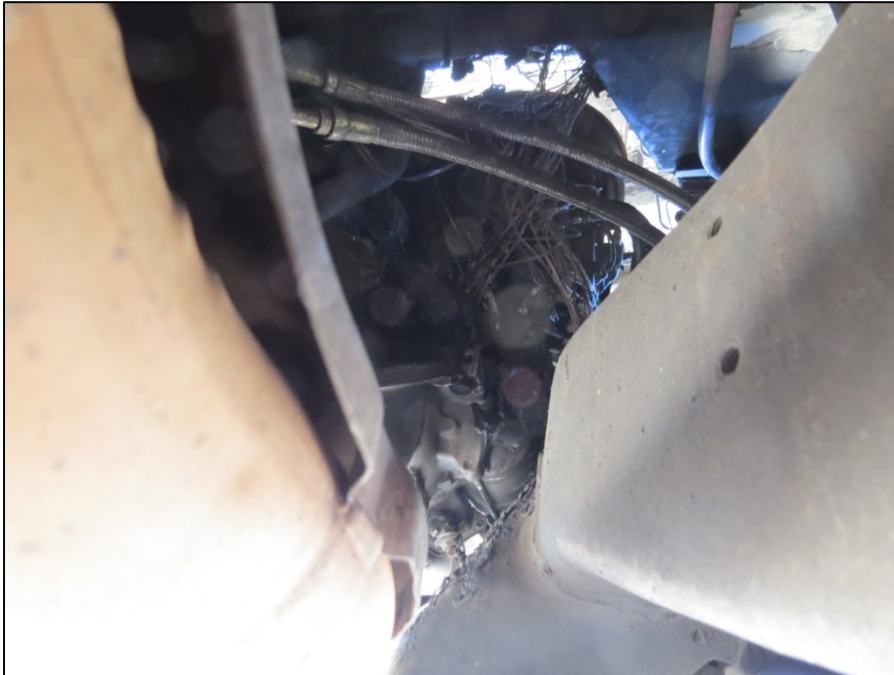
Photograph 9

Burned wiring in engine compartment.

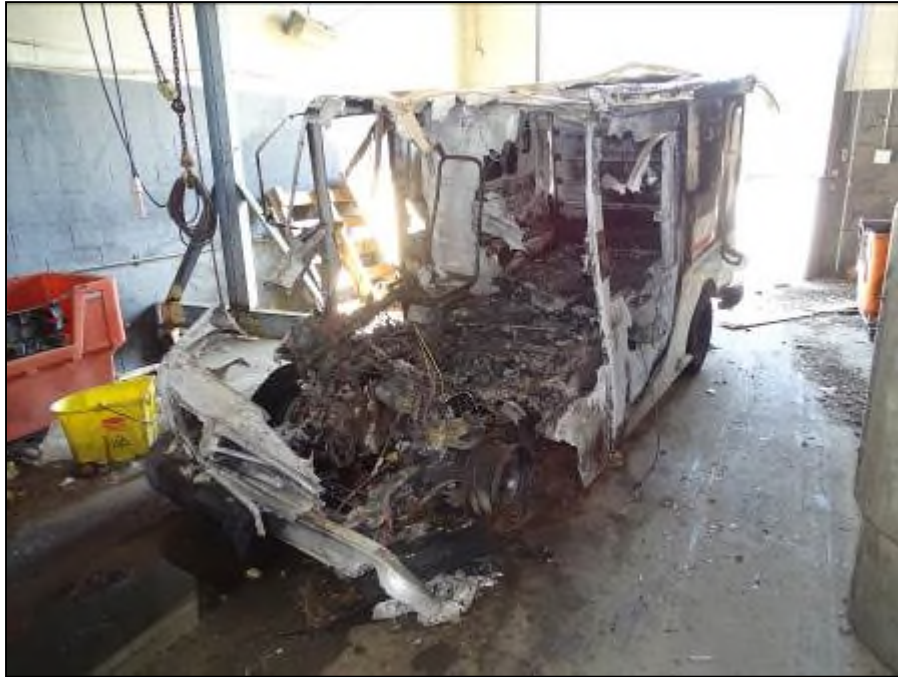
Photograph 1

View of the front and passenger sides of LLV 9200182.

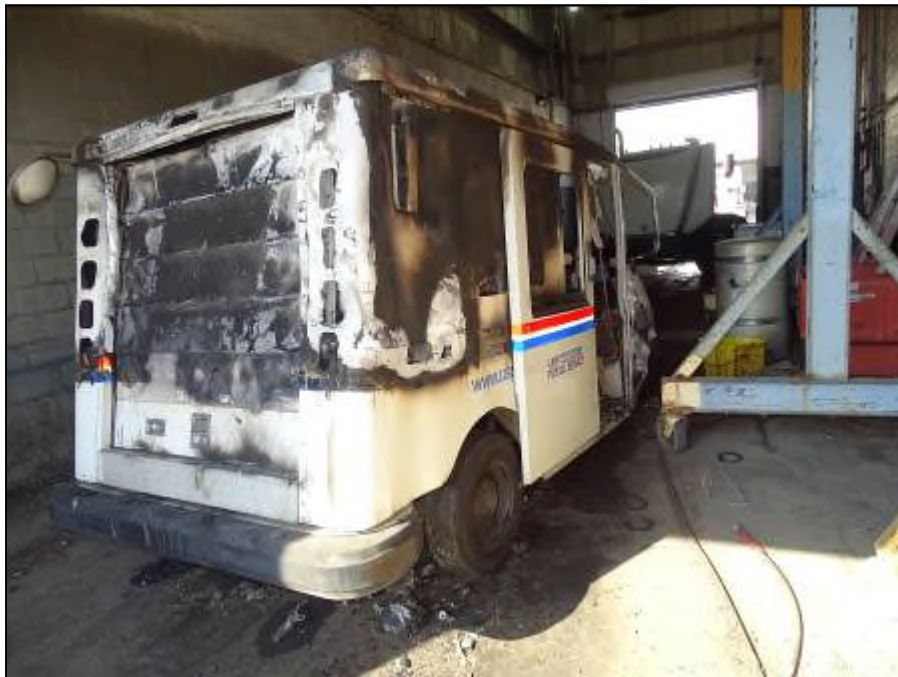
Photograph 2

View of the rear and driver sides of LLV 9200182.

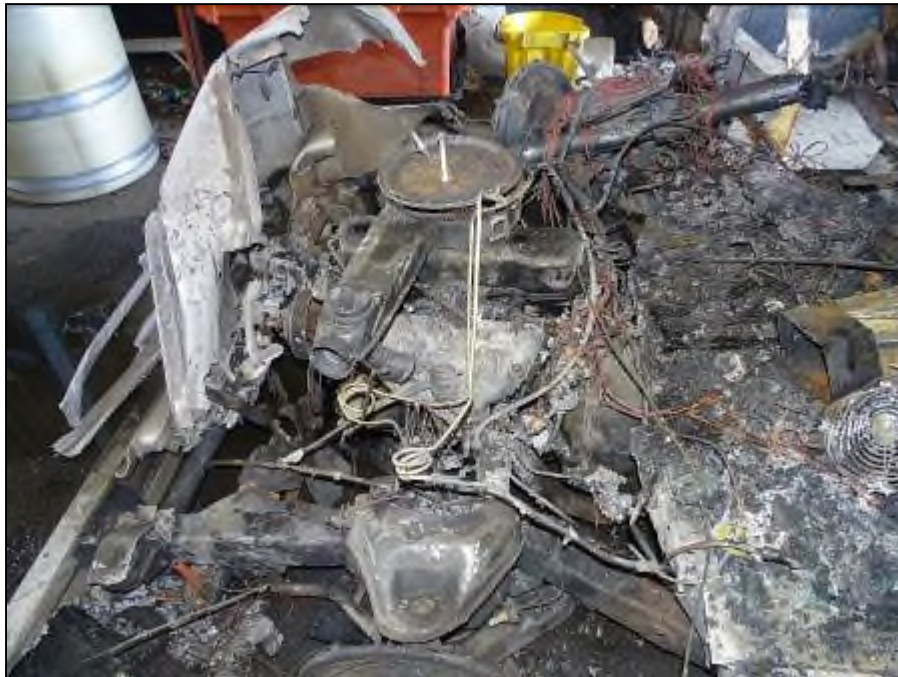
Photograph 3

The engine compartment was examined. The most severe fire damage was observed in the engine compartment at the rear of the engine in the area of the fuel filter. The fuel filter was an AC Delco model and was located along the left rear side of the engine. The engine fuel lines were also located along the left side of the engine. An examination of the fuel filter revealed the top fuel line connector was loose at the fuel filter.

View of the engine compartment.

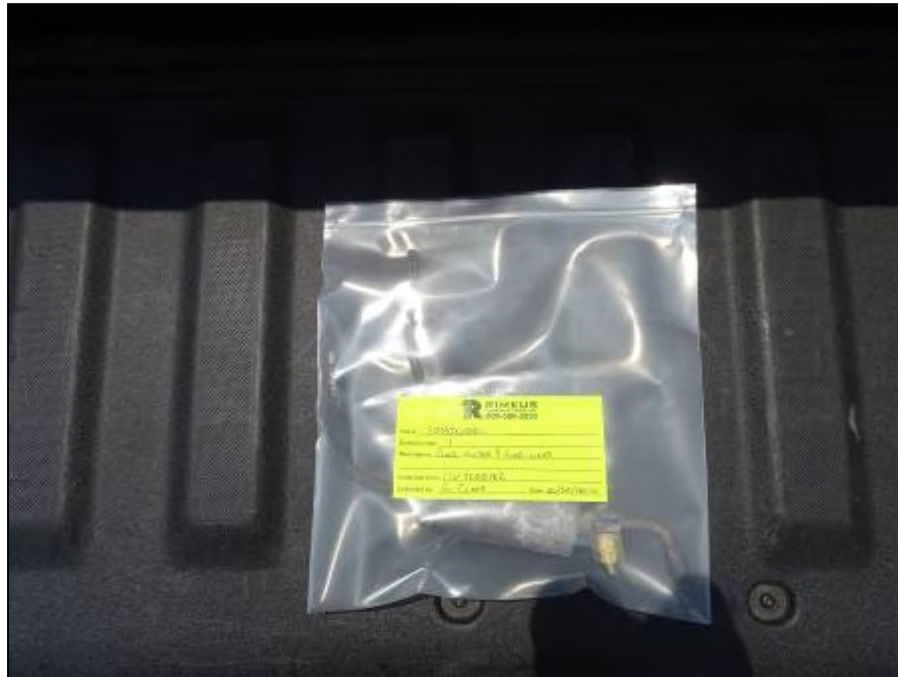
Photograph 5

The AC Delco fuel filter along with portions of the upper and lower fuel lines were collected as evidence and were submitted to Jack R. Kennedy, III, IAAI-CFI, Technical Fire Manager. The collected evidence was consistent with the cause of the fire.

View of the evidence collected.

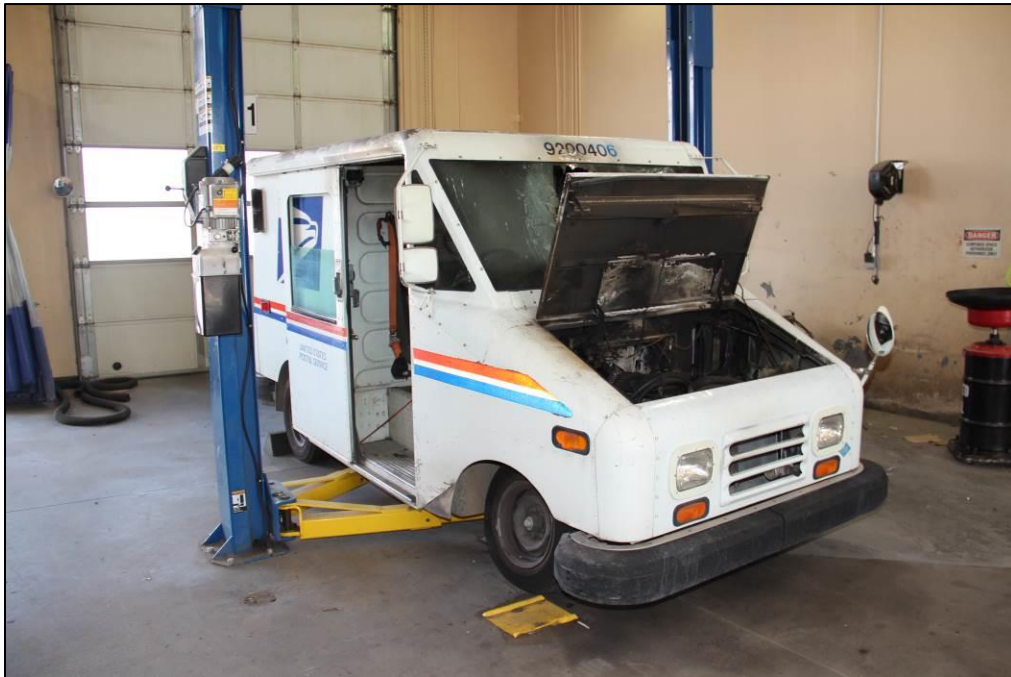
Photograph 1

The vehicle exhibited fire damage to the windshield and hood. Minor smoke staining and soot deposit were noted along the upper edges of the door openings. No obvious pre-fire damage was noted.

Involved vehicle as presented for inspection.

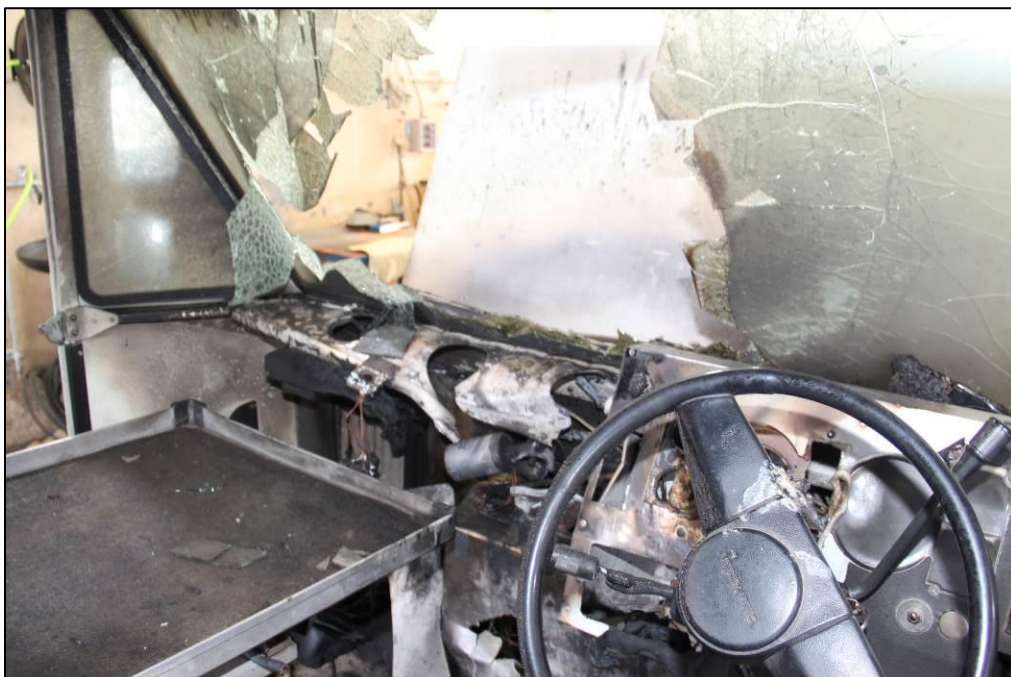
Photograph 2

Interior of involved vehicle.

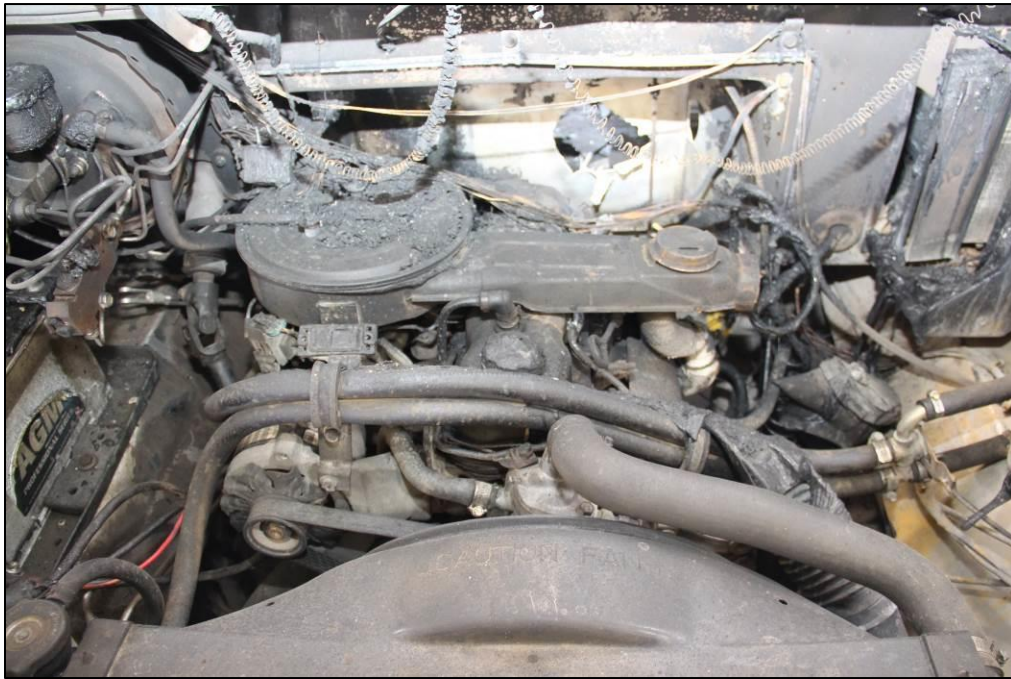
Photograph 3
Engine compartment.

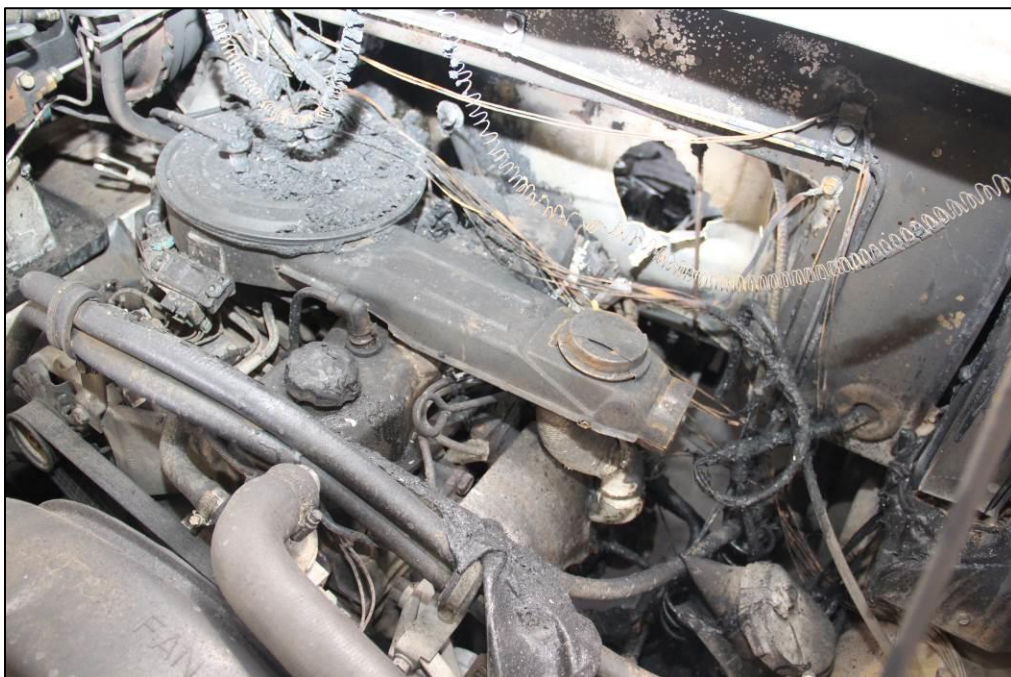
1. The fire originated within the engine compartment, in and around the bulkhead area.
2. Ignition scenarios included an electrical failure that caused the failure of the control arm and a possible fuel leak.

Photograph 4
Area of fire origin, along bulkhead, rear of engine compartment.

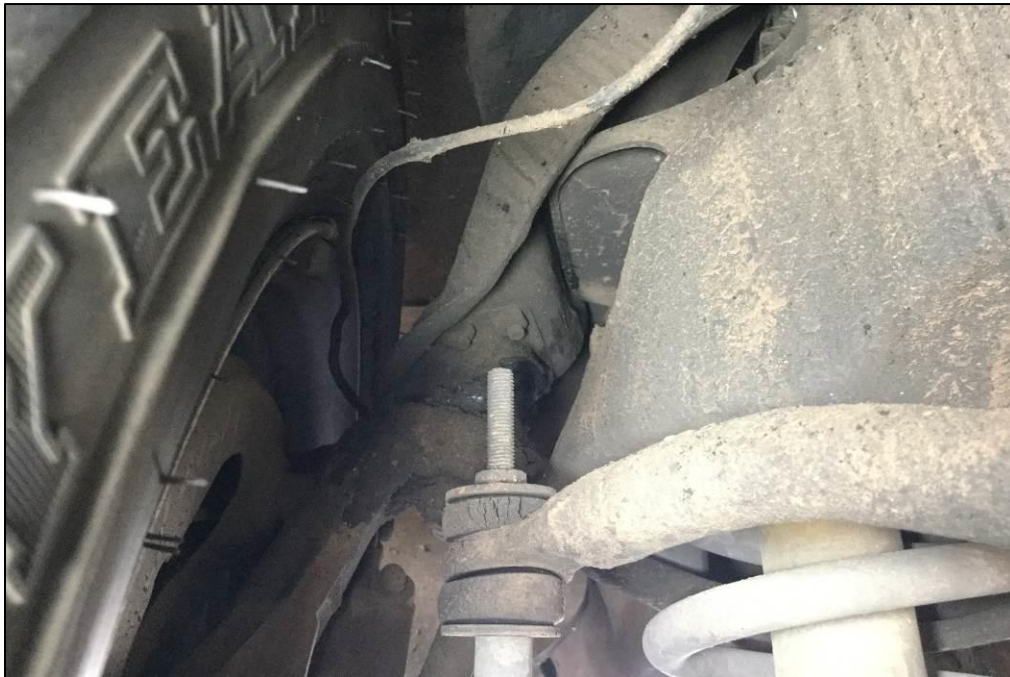
Photograph 5

Broken control arm, driver's side.

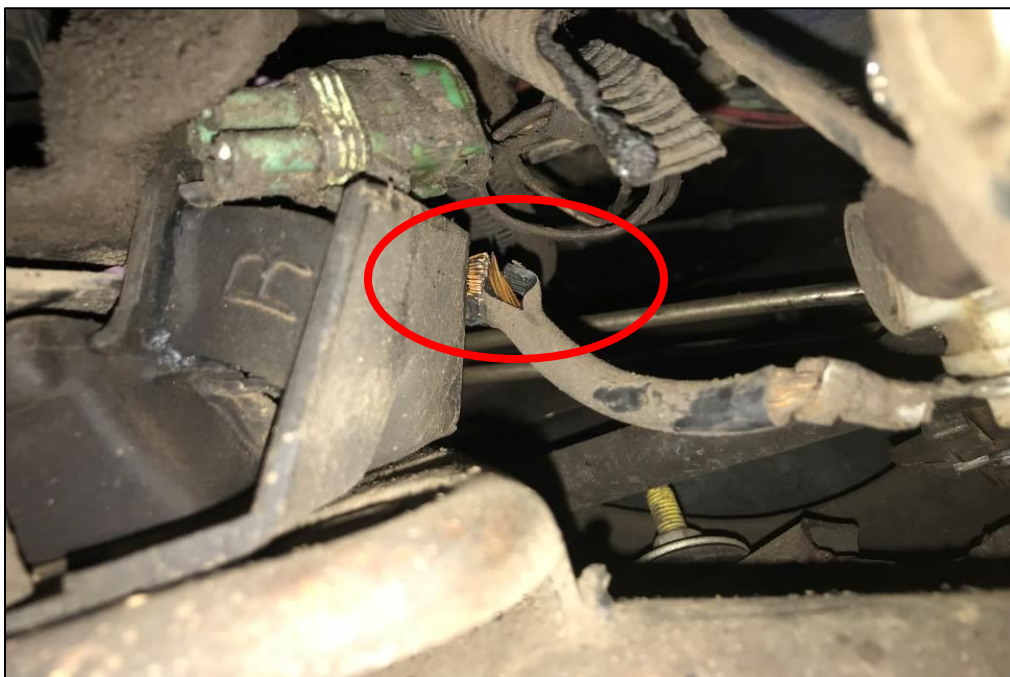
Photograph 6

Damaged positive starter cable.

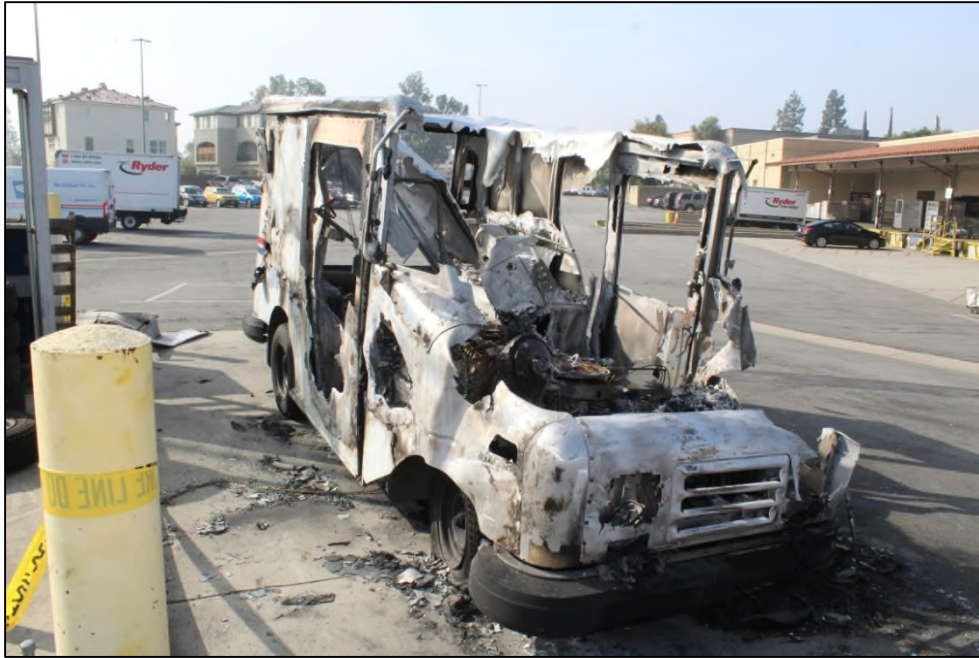
Photograph 1

Subject LLV. Right side and front.

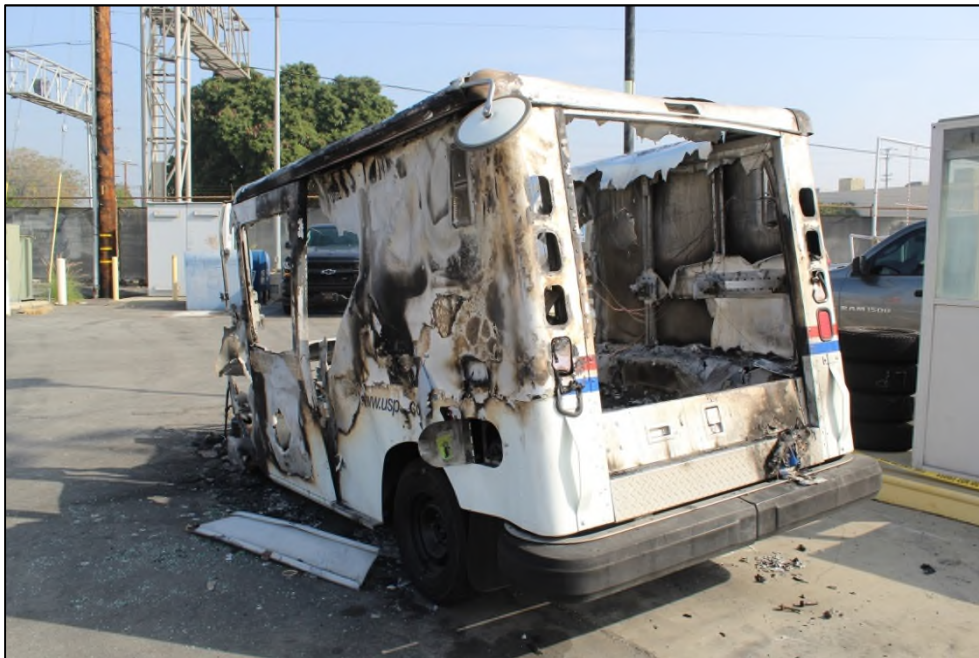
Photograph 2

LLV left side and rear.

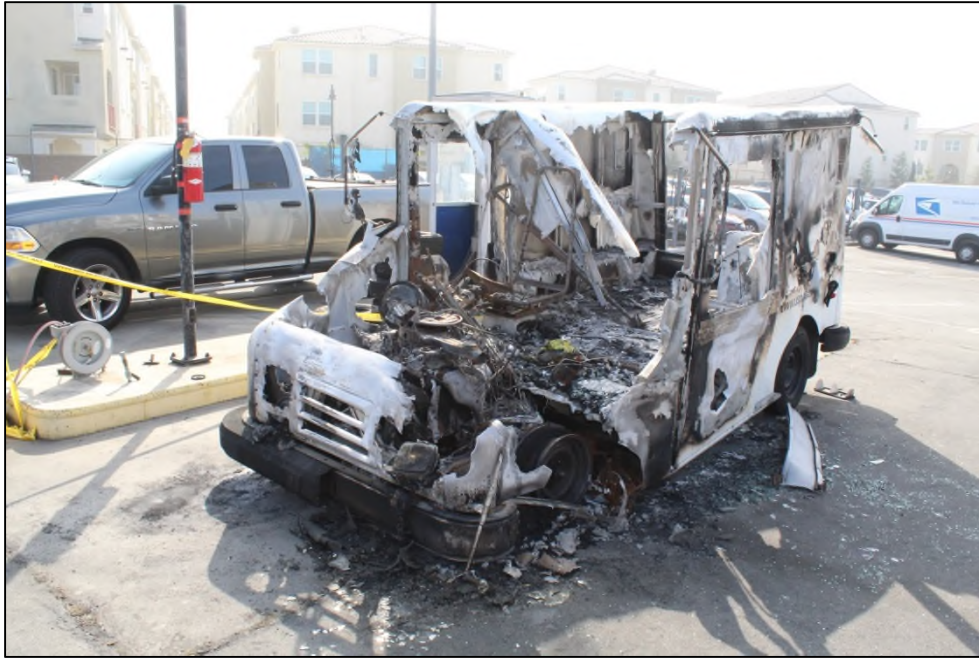
Photograph 3
LLV left side and front.

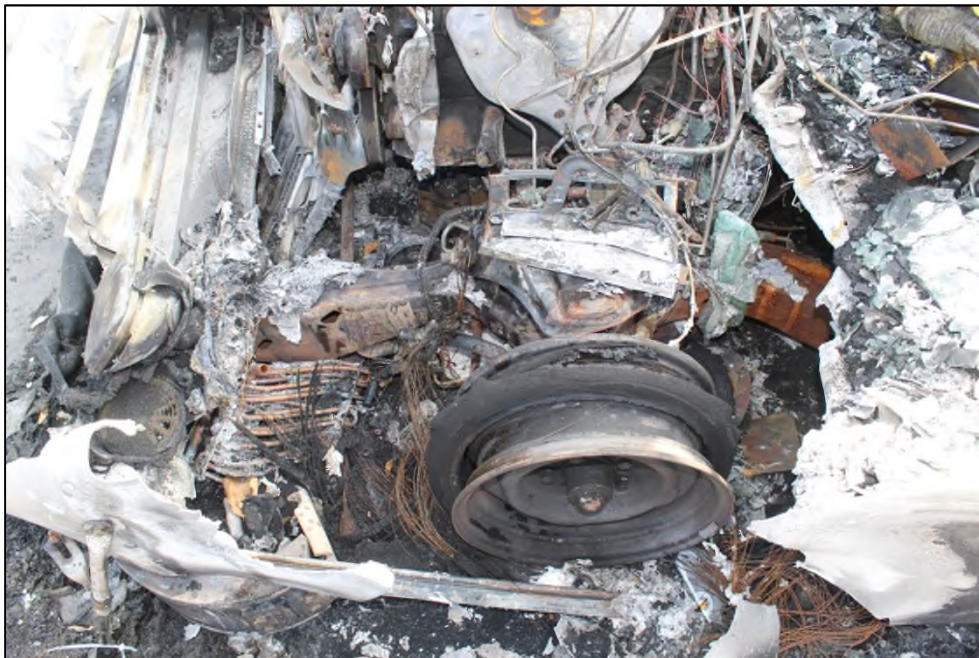
Photograph 4
LLV engine compartment, left side.

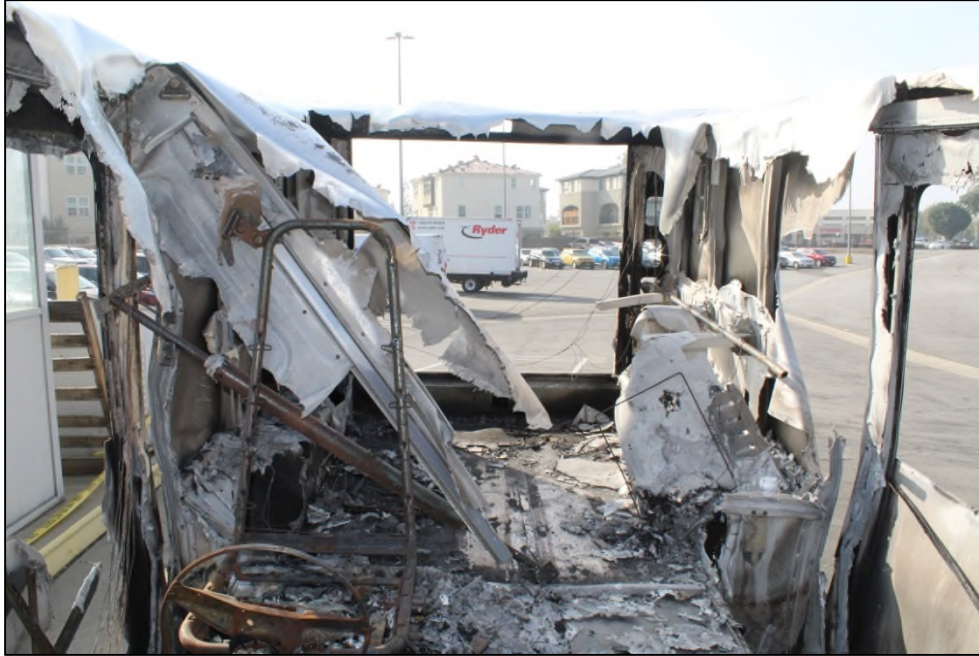
Photograph 5

The interior of the vehicle.

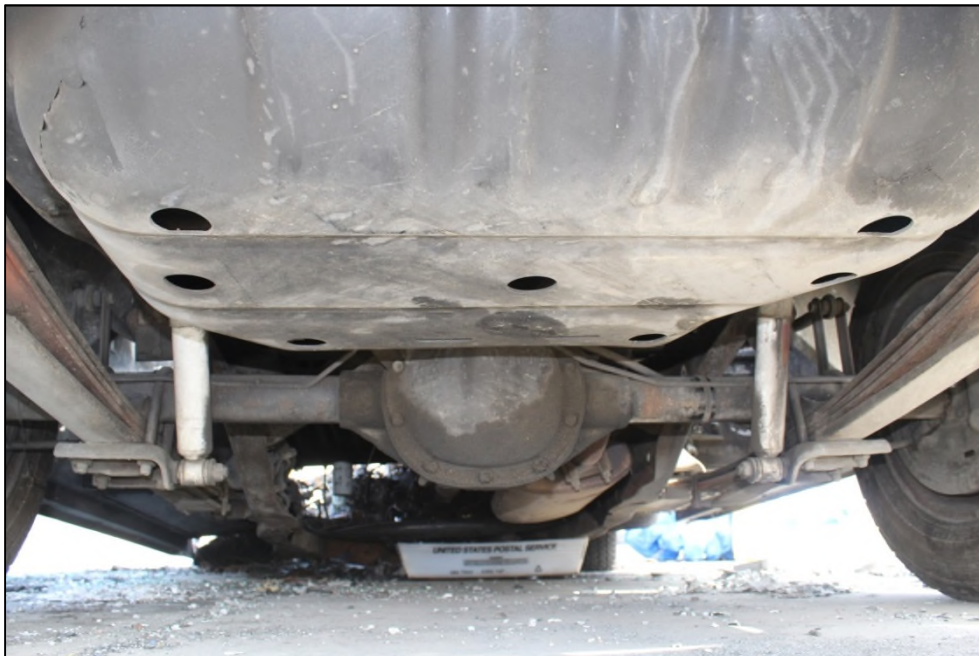
Photograph 6

The undercarriage of the vehicle.

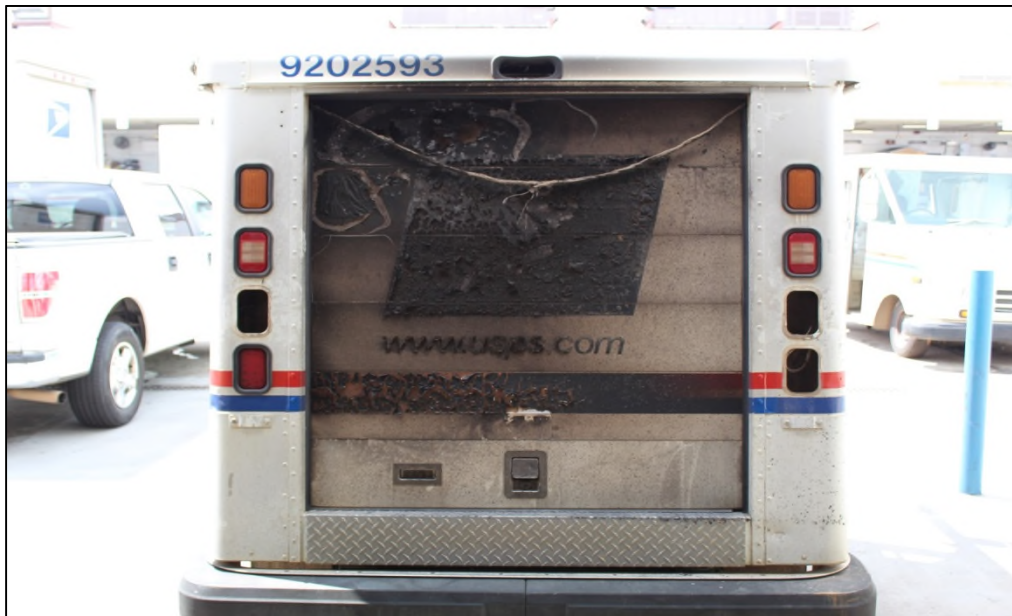
Photograph 1

The rear of the vehicle. Note the blistering and burn patterns from the top left corner downward.

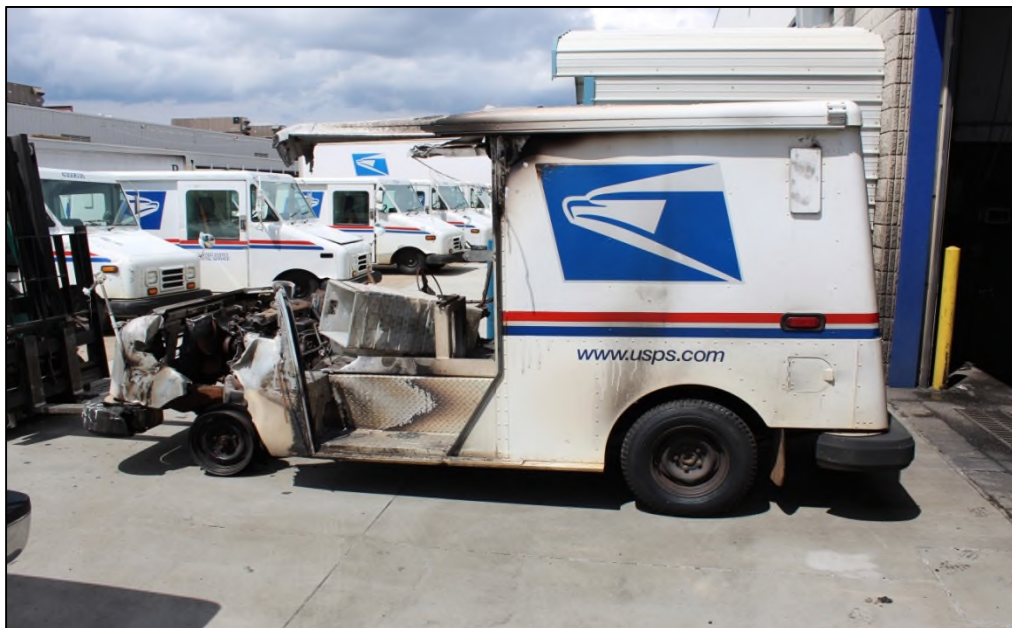
Photograph 2

The mail side of the vehicle. Note the low burn patterns on the step going from front to rear. Also note the front tire was missing due to low heavy damage in the left front.

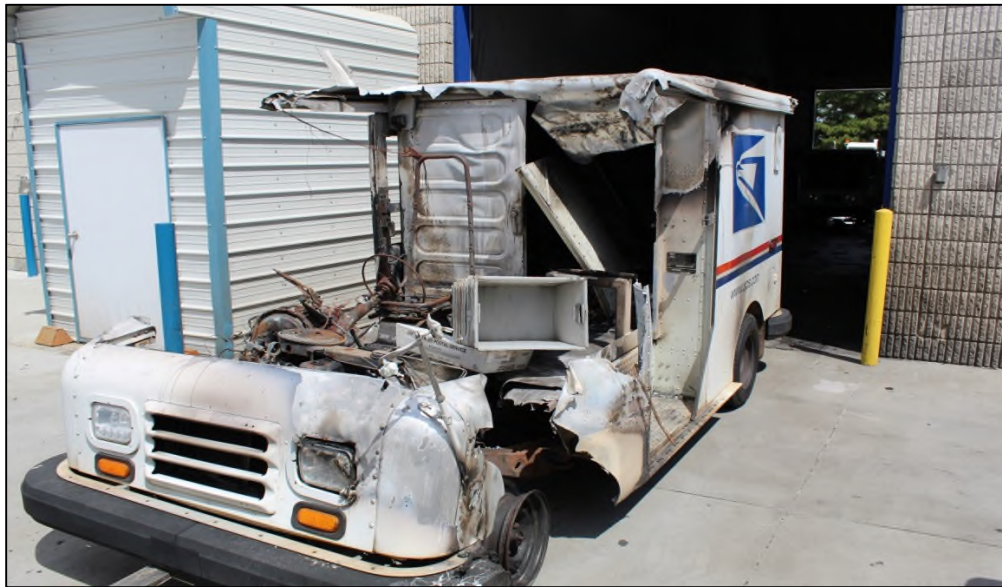
Photograph 3

The front of the vehicle showing the fire burned from left to right as evident by the left from corner. The damage to the lower part of the vehicle was indication of the fire originating lower in the engine compartment.

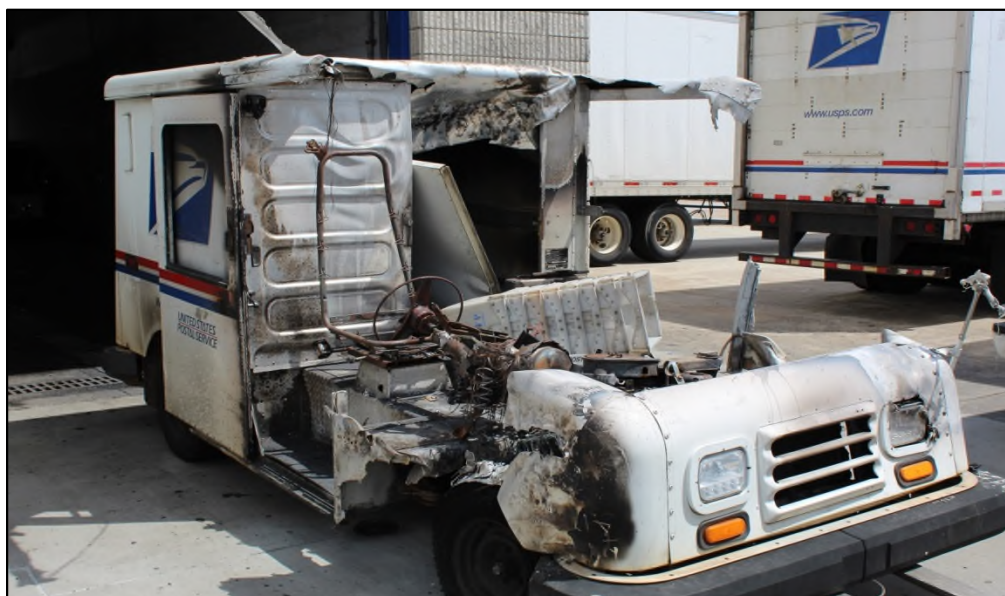
Photograph 4

Damage to driver's side and front of the vehicle was equally as bad as the left side. It appeared the fire traveled from left to right in the engine compartment before consuming the driver's compartment.

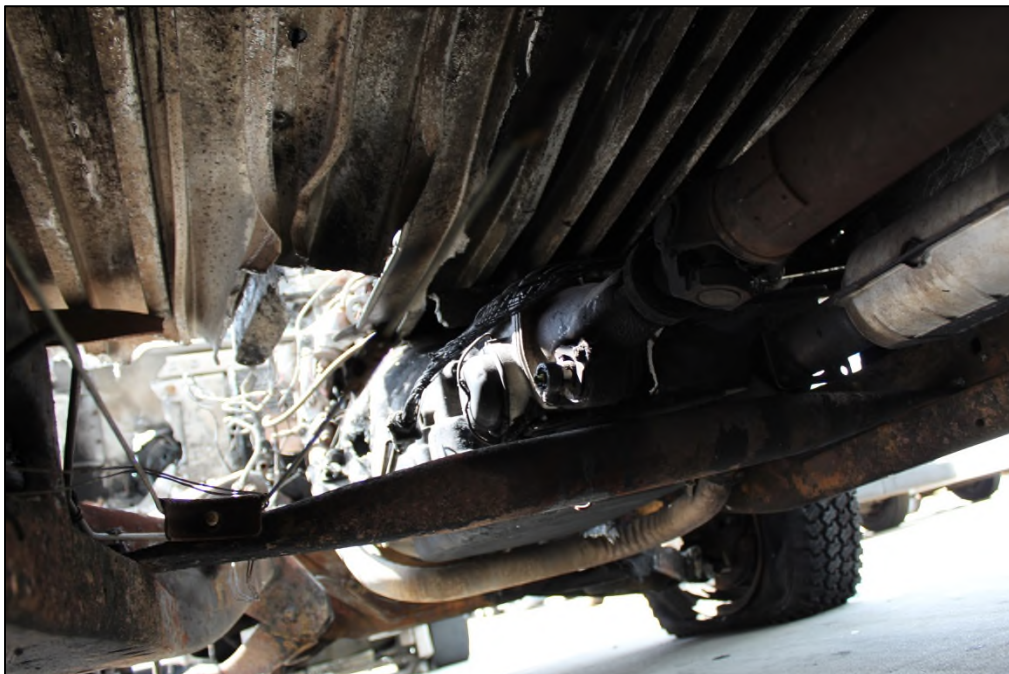
Photograph 6
The undercarriage looking towards the front and the damage around the transmission.

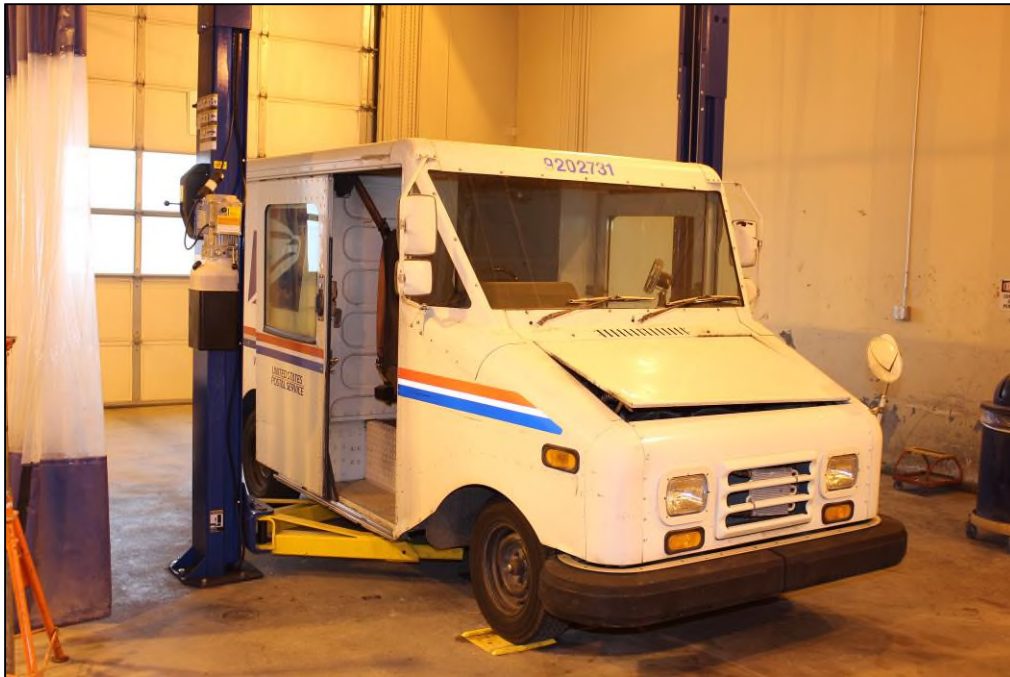
Photograph 1
Involved LLV 9202731.

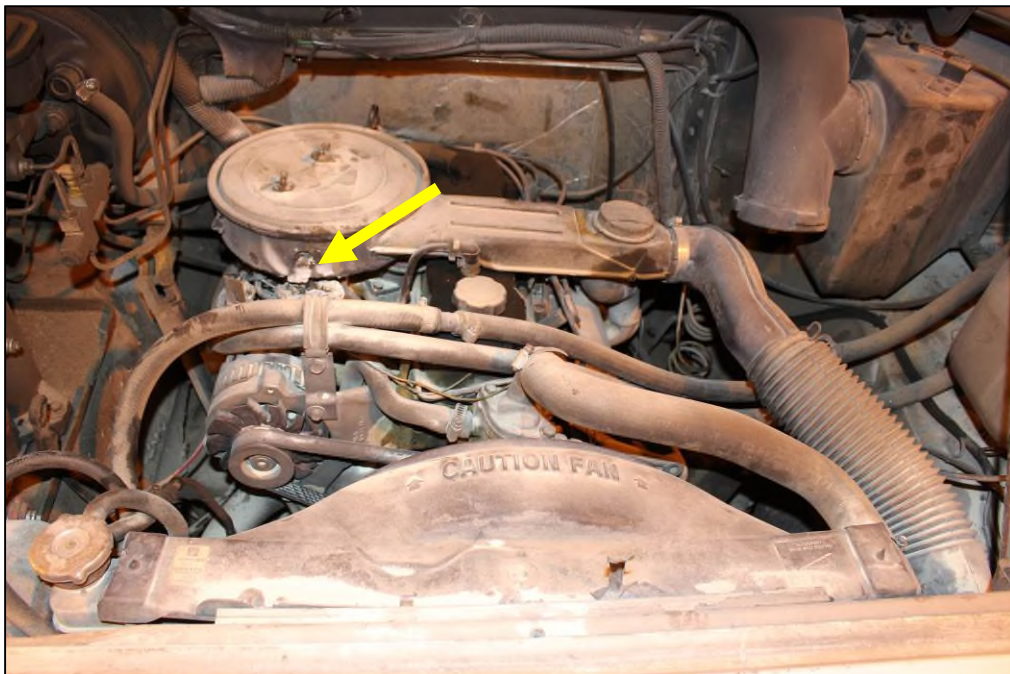
Photograph 2
Engine compartment; arrow denotes area of fire origin.

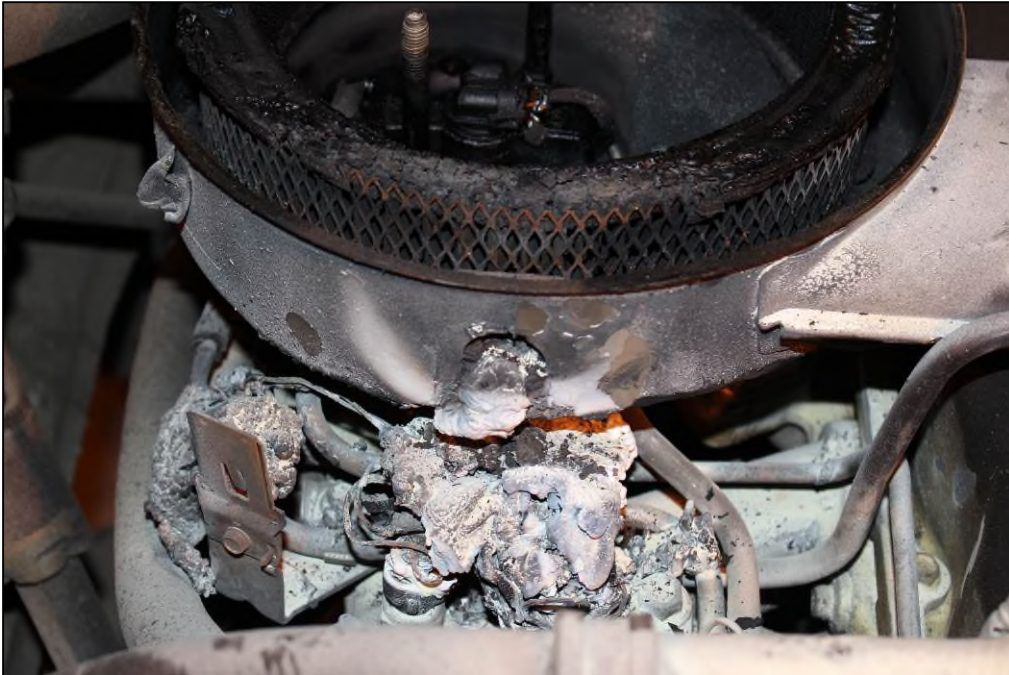
Photograph 3
Area of fire origin.

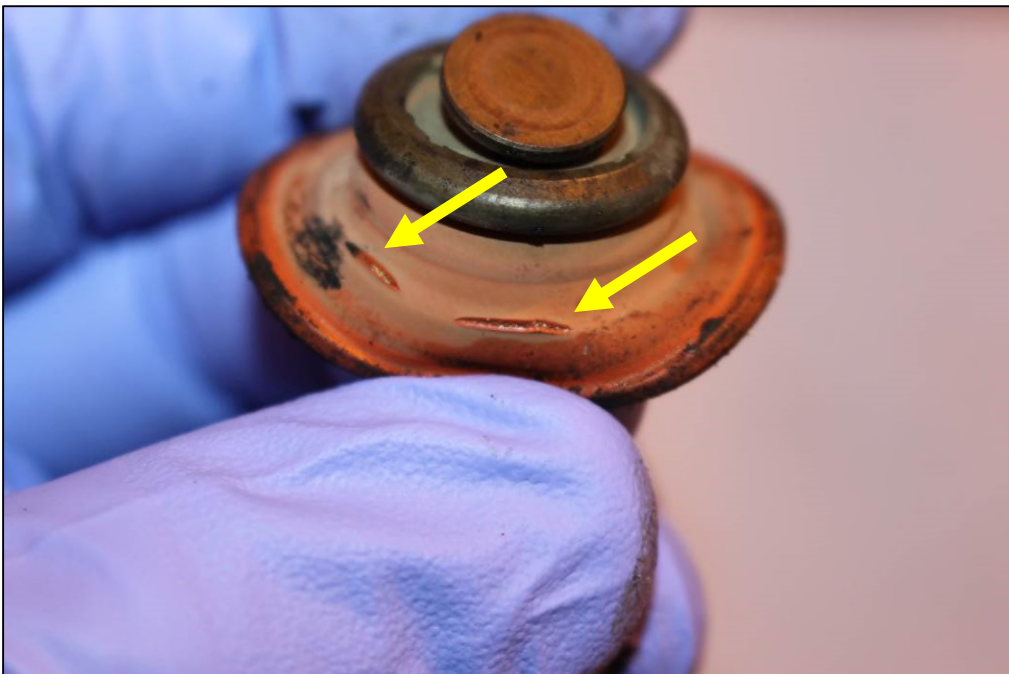
Photograph 4
Tears observed in fuel pressure regulator diaphragm.
